## Mechanism of failure eleven years following a Buechel Pappas hip resurfacing

Ajay MALVIYA, Steven LOBAZ, James HOLLAND

*From Freeman Hospital, Newcastle upon Tyne, UK*

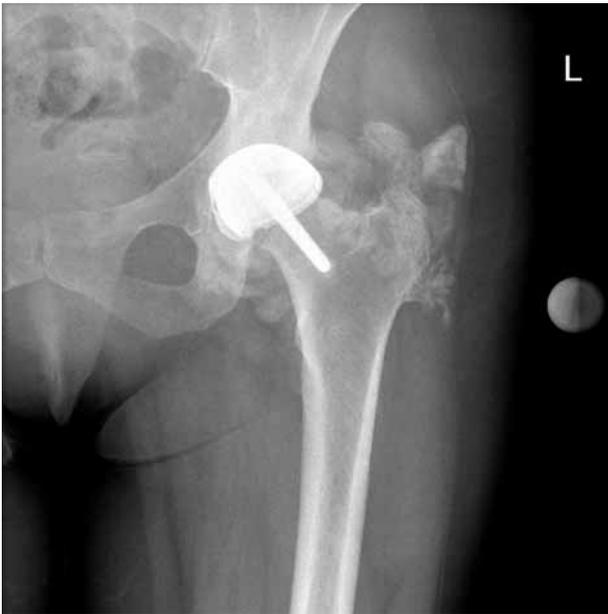
*Fig. 1.* — Radiograph at presentation suggesting heterotopic bone formation with concern about a neoplastic process.

ossification and calcification were noted on radiographs. This was investigated further by MRI scan which revealed a well-defined large soft tissue mass around the lateral and posterior aspects of the femoral neck. A biopsy of the mass was undertaken to exclude a neoplastic lesion. This revealed the presence of wear debris and excluded an infective or neoplastic process. Further radiographs showed a collapse and obvious wear of the prosthesis with further progression of radiological appearance of presumed heterotopic ossification (fig 1). A decision was made to revise the left hip to a total hip replacement.

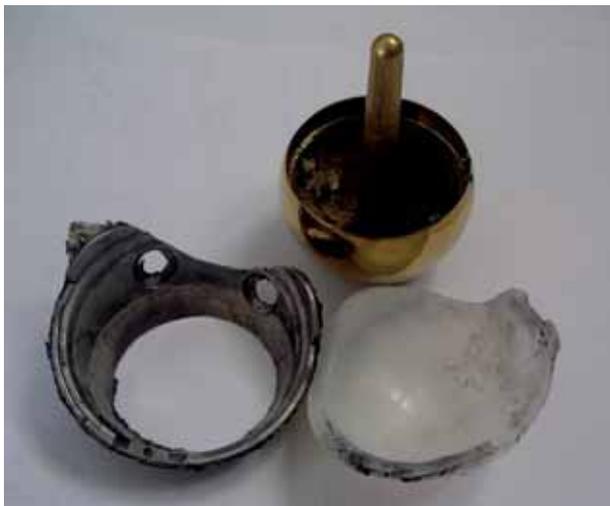
During surgery extensive black pigmentation of the tissues around the hip was noted, with lumps of soft tissue mass in the areas of suspected heterotopic ossification. The polyethylene liner had worn through and the head had eroded into the acetabular metal shell (fig 2). The titanium nitride coating of the head was burnished. The femoral component was knocked free of the femoral head revealing intact bleeding femoral head cancellous bone beneath. The acetabular polyethylene remnant was loose and lifted free. The acetabular metal shell was fully osseointegrated and worn through to

bone in the dome of the acetabulum. Notable was complete absence of osteolysis. A hybrid hip replacement with an uncemented acetabular component and a cemented stem was successfully performed.

**Fig. 2.** — The explanted prosthesis showing the worn metal backing with the polyethylene liner and the titanium nitride coated femoral component.

This case, however, outlines the problems with thin polythene liners and titanium bearing surfaces. After wearing out the liner, the titanium articulating surface produced large amount of metal debris which mimicked heterotopic ossification. The titanium debris with its black pigmentation causes staining of all the surrounding tissue with obvious soft tissue reaction. Although the prosthesis lasted more than ten years the failure was catastrophic and this would be a good enough indication to avoid such bearing surface. It has been shown in the past that a femoral component that is made of titanium alloy can undergo severe wear of the surface with liberation of potentially toxic local concentrations of metal debris into the surrounding tissues and may contribute to infection and loosening (1).

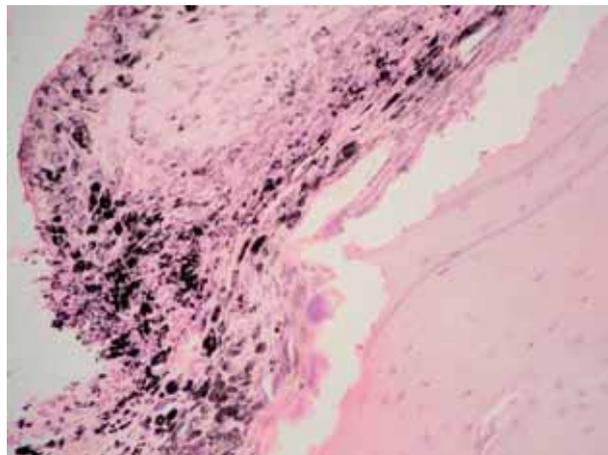
On histological analysis, the specimen of soft tissue lumps revealed features suggestive of tissue response to wear, containing titanium and polyethylene debris with no evidence of heterotopic ossification (fig 4). The specimen from the bone revealed further tissue reaction to wear debris.

**Fig. 4.** — Histology of soft tissue showing inflammatory response to metal and polyethylene debris.
