Stem fracture of a collarless, polished, double-taper cemented femoral prosthesis : A case report

Dipak RAJ, Benjamin D. COUPE, Graham S. KEENE

From the Addenbrokes Hospital, Cambridge, United Kingdom

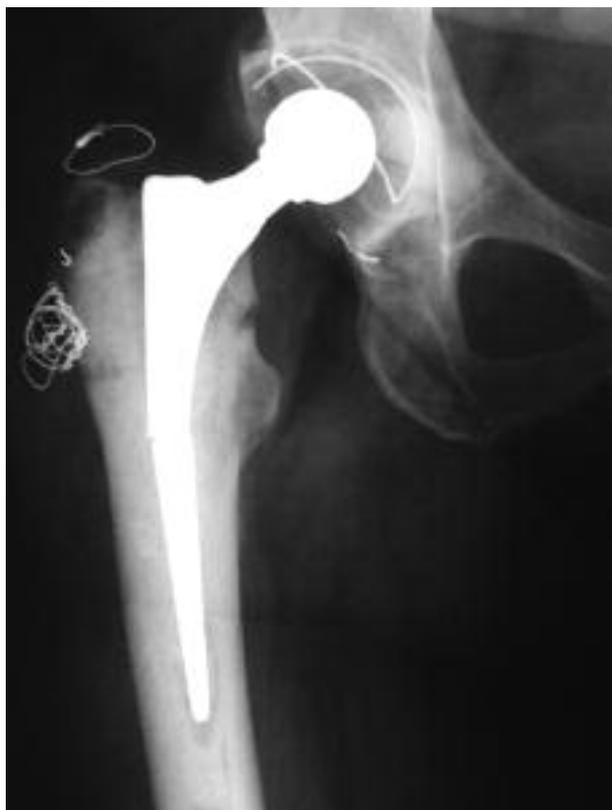
Fig. 1. — Antero-posterior radiograph showing fracture of the stem.

Unfortunately, she developed pain and restriction of mobility, approximately three years after primary hip replacement arthroplasty. She was complaining of pain over the lateral aspect of the hip, groin and buttock. Pain was radiating to the knee joint. The patient was unable to walk for more than 15 minutes, despite the aid of two crutches. Inflammatory markers (CRP and ESR) and white cell count were within normal limits. Plain radiographs showed a fracture of the stem of the prosthesis, with loosening

of the proximal part of the component (fig 1). The hip was aspirated in the operating theatre under aseptic conditions. Sterile fluid was obtained. The patient went on to have a revision of the fractured component. Clinically, there was no evidence of infection. The distal part of the stem was found to be well fixed, and a femoral split was required to remove it. The femur was reconstructed with a long uncemented ZMR stem (Zimmer UK Ltd) and Dall-Miles cables. The acetabular component was revised to an uncemented Trilogy cup (Zimmer UK Ltd). The microbiology and histology reports confirmed that there was no evidence of infection. Rehabilitation consisted of physiotherapy and progressive protected weight bearing over a three-month period. Six months following revision surgery, the patient was walking moderate distances with the aid of one stick. The femoral osteotomy was uniting radiographically.

An analysis of the fractured stem was undertaken by the manufacturer. No divergence from their specifications was found. The stem had fractured 6.5 cm from the tip. Scanning electron microscopy showed fatigue striations, indicating failure by fatigue.

The manufacturer originally put a maximum weight limit on size 0 CPT stem to 70 kg. In this case the patient was 22.5 kg beyond the maximum weight limit. We feel that this could be a major factor contributing to the stem fracture. The short offset obtained with the small prosthesis results in increased abductor forces in order to maintain normal gait and may have resulted in the failure of the abductor mechanism. Failure of the abductor mechanism is a recognised complication of the anterolateral approach to the hip. In this case two further procedures were required to repair the abductors. Post-operatively, the patient had superficial infection. This could also be a contributory

factor to the failure of the abductor mechanism. It is thought that abnormal abductor function increases the stresses to which the femoral component is subjected, thus increasing the risk of fracture.

This case study highlights that stem fracture can still occur with modern implants. In an overweight patient, size 0 CPT stem should be avoided.
