## Femoral prosthesis neck fracture following total hip arthroplasty : A case report

Bhavuk GARG, Ravi MITTAL, Shishir RASTOGI

*From All India Institute of Medical Sciences, New Delhi, India*

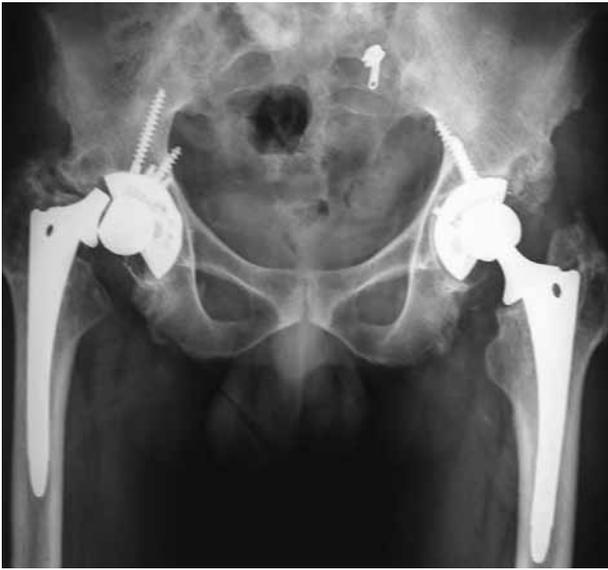
In March 2000, a 25-year-old male patient (height = 174 cm, weight = 78 kg) with ankylosing spondylitis with bilateral hip involvement underwent bilateral uncemented total hip replacement with a Co-Cr alloy fully porous-coated (titanium porocoat) size 10 AML cementless stem and a cementless Duraloc cup (DePuy) with a small femoral neck. The patient did well with no complications. In September 2006, he felt sudden pain in his right hip and heard a cracking sound while climbing stairs, and fell to the ground. He was no longer able to bear weight on his right limb. He was brought to our emergency department where a diagnosis of fracture of the femoral prosthesis neck was made on the basis of radiographs (Fig. 1). Three days later, he underwent a revision arthroplasty of the right hip (Long revision AML cementless femoral stem of size 10 and long skirted neck) using an extended trochanteric osteotomy (Fig. 2).

**Fig. 1.** — Femoral prosthesis neck fracture in a modular hip design system.

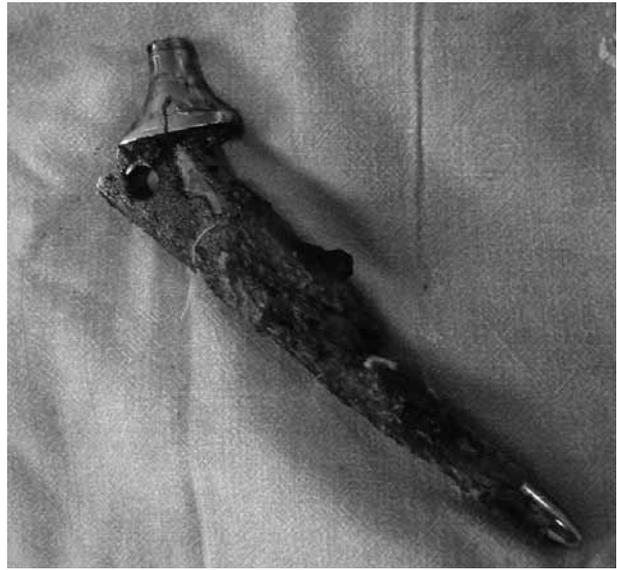
**Fig. 3.** — Intraoperative photograph of the retrieved implant showing fracture of the femoral neck.

Intraoperatively, the femoral prosthesis was found to be broken through the neck taper just below the level of the head of the prosthesis (Fig. 3 & 4). The femoral stem was found to be well fixed, without

any evidence of loosening. No evidence of component malpositioning was present. No signs of corrosion or defect of the material were noted on the femoral neck or head ; however detailed metallurgical analysis was not done because of lack of facilities.

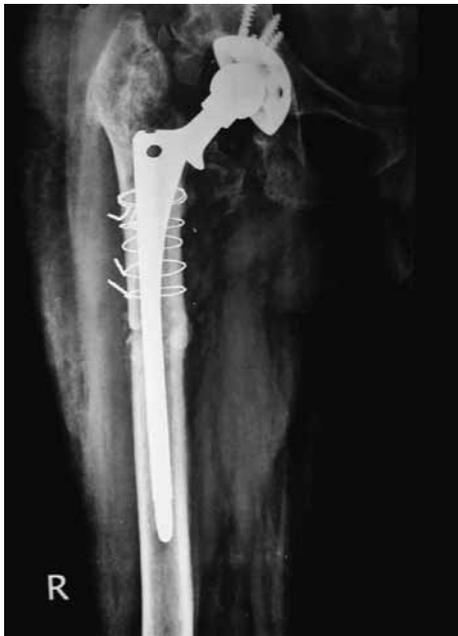
**Fig. 2.** — Postoperative radiograph of same patient following revision using an extended trochanteric osteotomy.

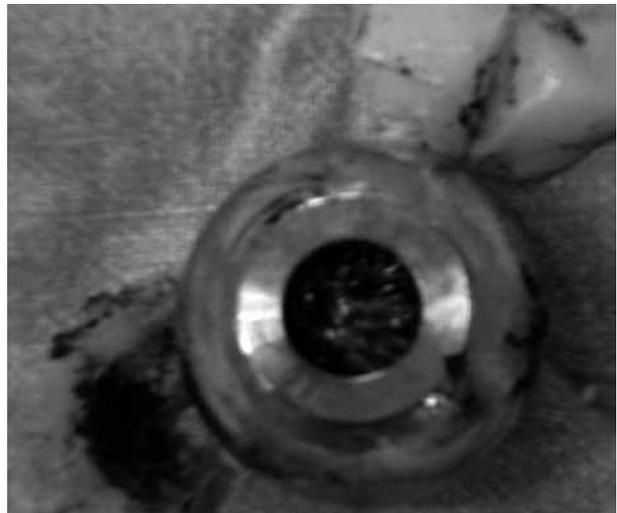
**Fig. 4.** — Intraoperative photograph of the retrieved prosthetic femoral head showing fracture of the femoral neck inside the femoral head.
