Intrapelvic migration of a guide pin during fixation of a hip fracture Who and what is to blame ?

Fares E. SAYEGH, Dionysios TSINTZAS, George A. KAPETANOS

From the General Hospital Papageorgiou, Aristotle University of Thessaloniki, Greece

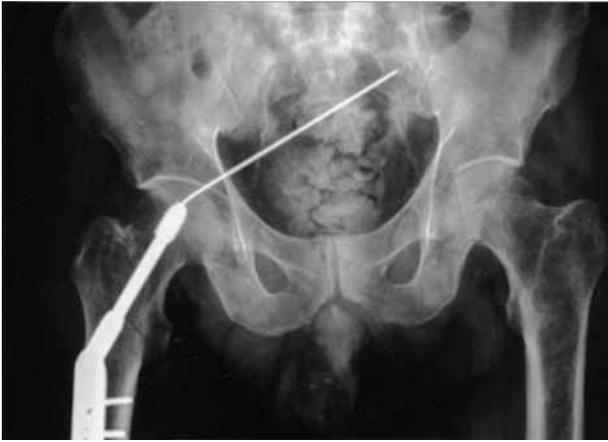
Fig. 1. — Immediate post-operative radiograph of the right hip showing intrapelvic migration of the threaded guide wire.

In our case, the migration of the guide wire into the pelvis was not noticed during surgery. The final check up of the operated hip with the image intensifier was neglected. The immediate postoperative radiograph showed almost complete intrapelvic protrusion of the guide pin. Such an unexpected complication, regardless of the final outcome causes embarrassment to the surgeon. Looking retrospectively into the causes of such an unpermissible complication, we could point out a number of possibilities.

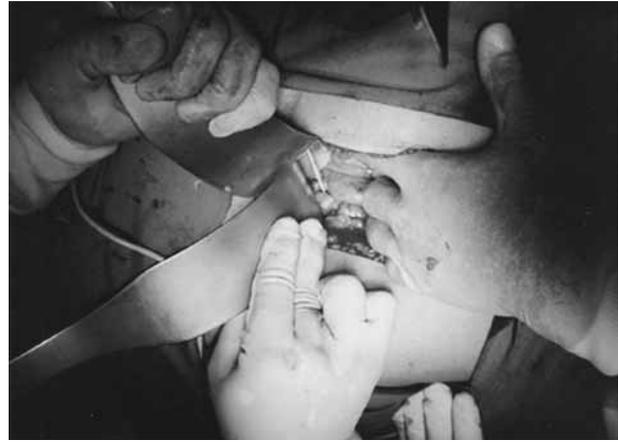
Fig. 2. — The guide wire as seen during laparotomy

fracture table and closed reduction of the hip fracture under the image intensifier was performed. A sliding compression hip screw was used to internally fix the fracture fragments. The standard and usual technical steps specified by the manufacturer for the application of a compression hip screw were followed. No difficulty was encountered during the surgery and the procedure was completed without any complications. A final check up of the operated hip with the image intensifier was not done. The routine post-operative radiograph of the right hip revealed intrapelvic migration of the threaded guide wire (fig 1). The patient was asymptomatic. He was informed of the complication and was promptly taken to the operating room for open laparotomy under general anaesthesia. During surgery the pin was seen to be lying over the intestines and no pelvic visceral damage was noted (fig 2). The bent guide wire was retrieved successfully from the abdomen without intra-operative or

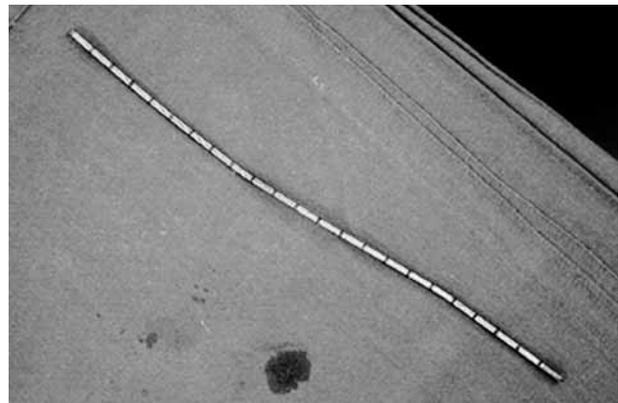
Fig. 3. — The retrieved bent guide wire

post-operative complications (fig 3). The progress of the patient over a 3-year follow-up was unaffected by this complication.

A similar complication could happen if the blocked flutes of the cannulated drill bits and taps are not properly cleaned before reusing (8), or if those supplied hardwares do not fulfill the specifications recommended by the manufacturer for the type of hip screw used. In our case, we are not sure if the wire used was bent or reused but it definitely did not belong to the instrument set supplied by the manufacturer for the type of hip screw used.
