## Fracture of the scapular spine in a patient with a Delta III prosthesis

Philippe DEBEER, Filip ROBYNS

*From the University Hospital Pellenberg, Pellenberg, Belgium*

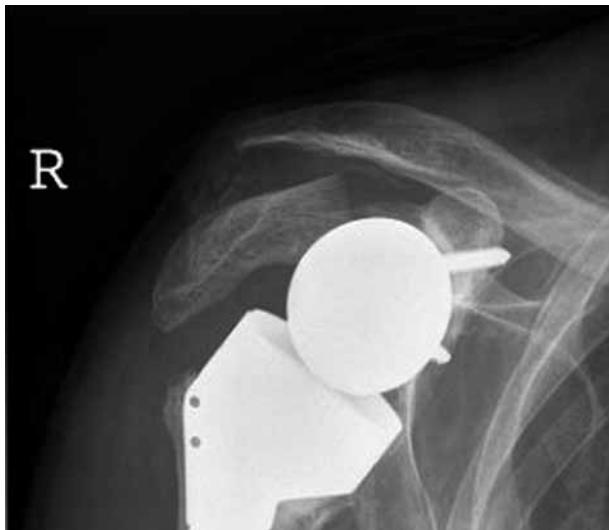
**Fig. 1.** — Standard radiographs of the right shoulder demonstrating the displaced scapular spine fracture. No loosening or damage to any of the Delta III components is noted.

we noted a haematoma and local tenderness over the posterior aspect of the acromion and the scapular spine. The mobility of the shoulder was painful and severely restricted. There was no evidence for any other associated injuries. Radiographs revealed a displaced fracture of the scapular spine. All components were stable without any sign of loosening of Delta III prosthetic components (fig 1). A CT scan confirmed these findings (fig 2). Osteosynthesis of the scapular spine was performed using a 7-hole 1/3 tubular plate, contoured over the scapular spine. An excellent reduction and good internal fixation was obtained (fig 3). Post-operatively the patient was placed in a sling for four weeks and only passive range of motion exercises were allowed. After four weeks the sling was discarded and active mobilisation of the shoulder was allowed. Two months postoperatively, the patient was pain free and had regained the same active and passive mobility as before the fall.

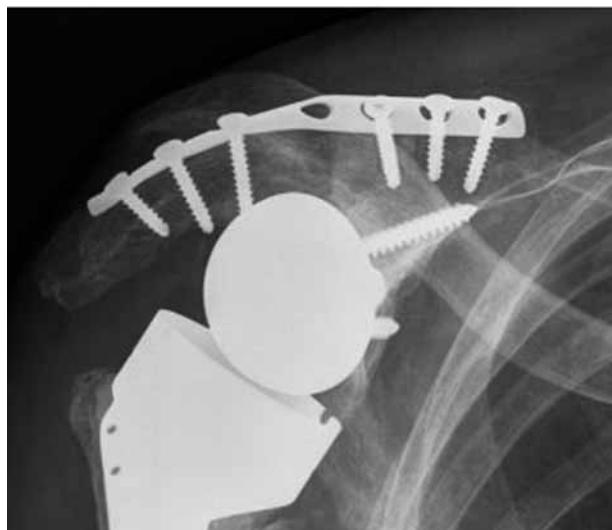
**Fig. 3.** — Standard radiograph of the right shoulder after internal fixation of the fracture.

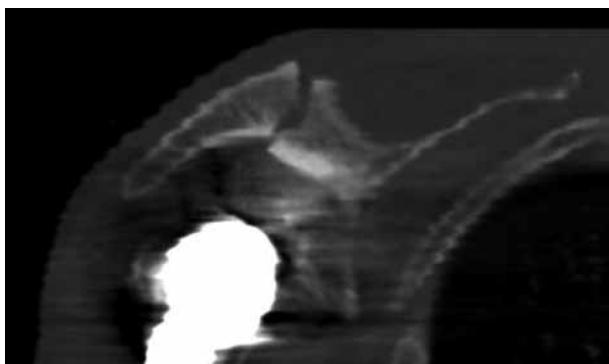
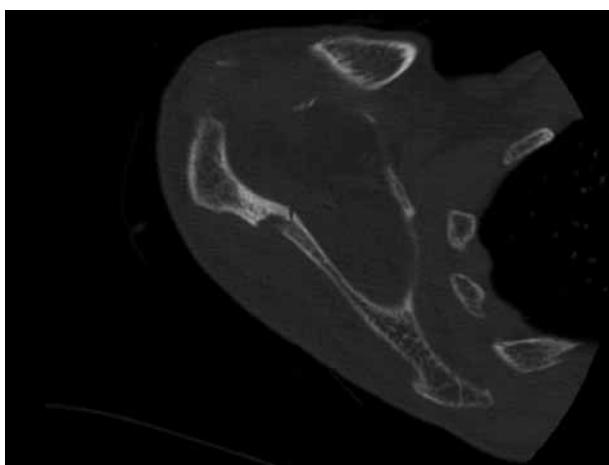
**Fig. 2.** — CT scan of the right shoulder
