# DISSOCIATION OF THE S-ROM\* METAL-BACKED POLYETHYLENE ACETABULAR LINER – A CASE REPORT AND LITERATURE REVIEW

H. P. BHINDA, S. P. SARKAR

The authors report a case of early failure of a total hip arthroplasty with dissociation of the polyethylene liner of an S-ROM Oblong Cup\*, which presented as a dislocation. Initial closed reduction of the dislocation was not possible. Open exploration of the hip revealed that the modular Poly Dial\* polyethylene acetabular liner had become dislodged from the acetabular cup. The liner was revised and a stable reduction of the hip was achieved. To our knowledge, no previous case of dissociation of the polyethylene liner from the S-ROM Oblong acetabular component has been reported. A review of the literature with other relevant cases is presented.

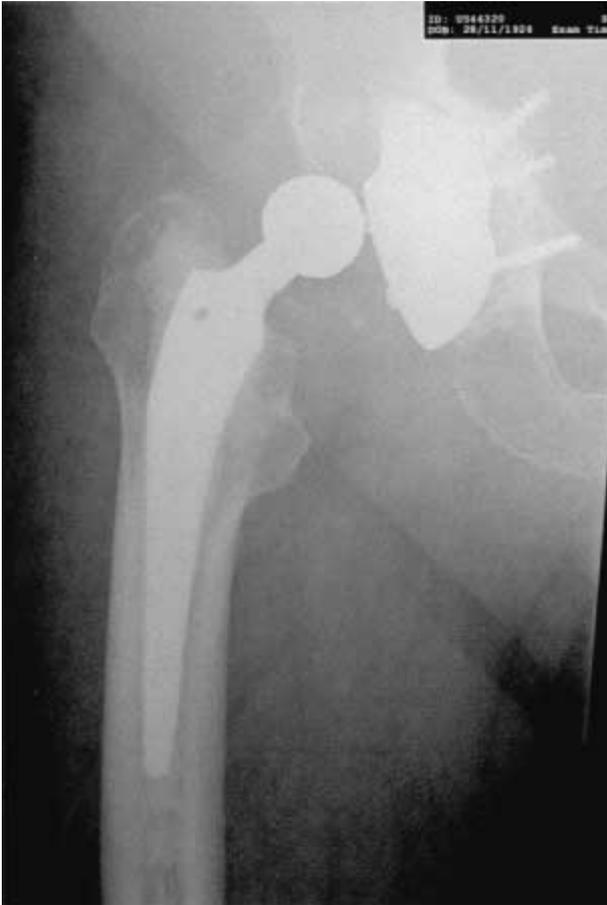
**Fig. 1.** — Radiograph showing dislocation of the total hip arthroplasty with the femoral head in a superolateral position.

A 75-year-old man was admitted with an apparent dislocation of a right total hip arthroplasty. There was no history of trauma or a fall. He had undergone acetabular revision to an S-ROM Oblong Cup nine months previously. He had been asymptomatic during the ensuing period. Clinical examination revealed no shortening or rotation of the limb, but he was unable to weight-bear or move the hip due to pain. Radiographs obtained on admission showed a dislocation with the femoral head in a superolateral position (fig 1). An attempt was made at closed reduction under general anaesthesia. A more concentric position of the femoral head was obtained, but the hip could not be fully reduced (fig 2).

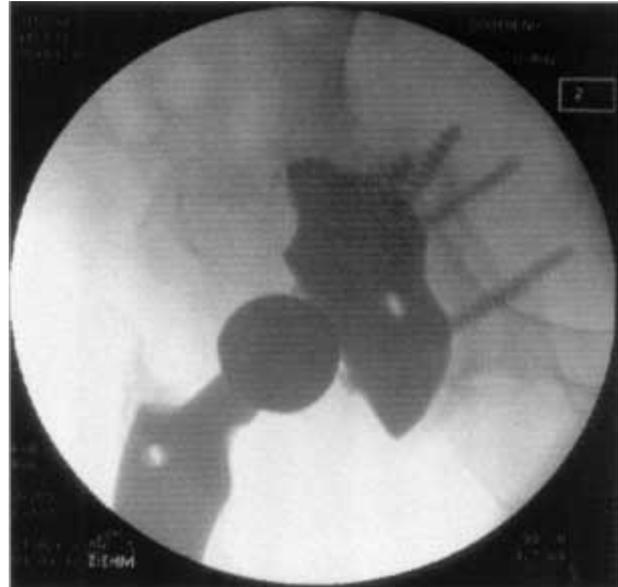
**Fig. 2.** — Image intensifier film after attempted closed reduction. The femoral head is in a more concentric position, but the hip is not fully reduced.

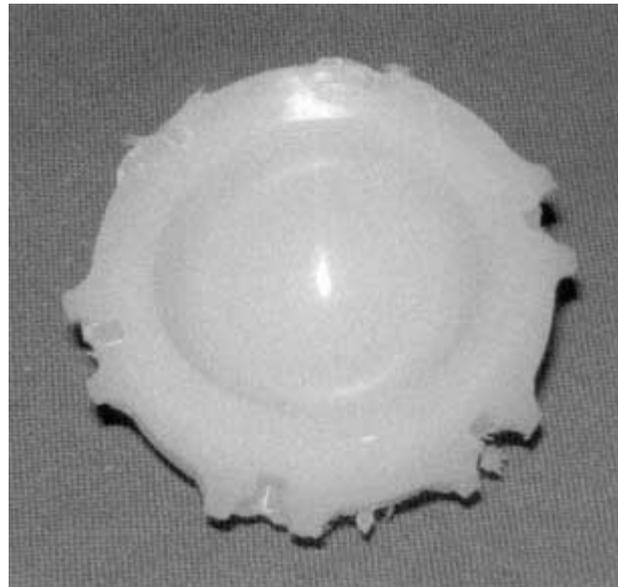
**Fig. 3.** — The dissociated polyethylene liner. Examination of the liner revealed irregularity of the slots around the rim where it had been attached to the cup with peripheral screws.

itself had become disengaged from its metal backing within the S-ROM Oblong acetabular cup. Examination of the liner revealed irregularity of the slots around the rim where it had been attached to the cup with peripheral screws (fig 3). The liner was revised and a stable reduction of the hip was achieved. Post-operative recovery was uneventful and the patient subsequently mobilised successfully.

The recognition of such component failures is an essential aspect of the surveillance and evaluation of new implants, and serves to highlight potential limitations and areas for improvement in implant design. In the current case, the method of fixation of the liner to the metal cup proved to be an area of concern.
