## CASE REPORT

# INTRAPELVIC MASS IN A YOUNG WOMAN WITH AN UNCEMENTED HIP ARTHROPLASTY

**Based on a case report in which wear of the polyethylene liner in an uncemented hip prosthesis led to the development of an intrapelvic mass, the pathogenesis, diagnosis and treatment are described. Characteristic osseous and soft tissue reactions caused by release of polyethylene particles to periarticular tissue are discussed as well as the differential diagnosis with infectious and malignant conditions. In the case treated, the differential diagnosis was also made with respect to gynecological pathology.**

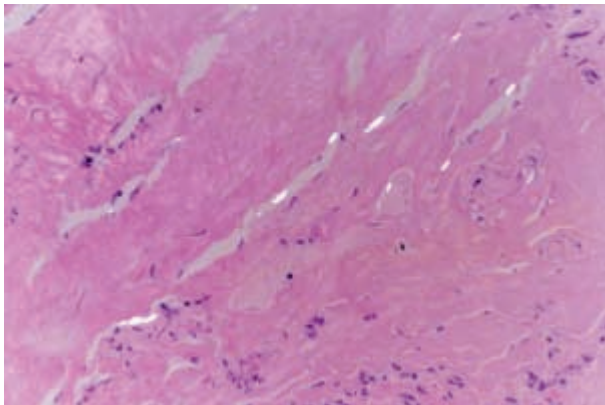
**Fig. 1.** — Histological appearance of cyst wall tissue taken at the laparotomy. Note the polyethylene wear debris seen as small birefringent particles between the collagen fibers. H & E stain, polarized light microscopy, magnification  $\times 200$ .

In the lower anterior quadrant of the acetabulum we found a small osteolytic lesion with no marked communication with the intrapelvic space. At the anterior rim of the acetabulum we found cystic tissue as the cyst evidently had originated from there. The acetabular component and head were replaced, and the granulomatous periarticular tissue was excised and elicited the same needle-shaped birefringent particles as mentioned above.

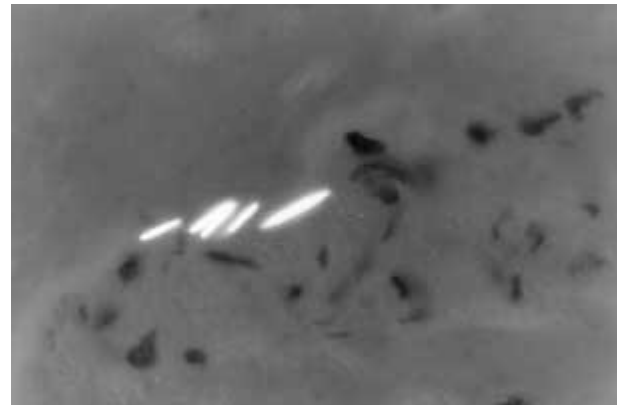
**Fig. 2.** — Same tissue sample at higher magnification  $\times 400$ . Note the needle-shape of the polyethylene particles, which measure from 7 to 14 microns.

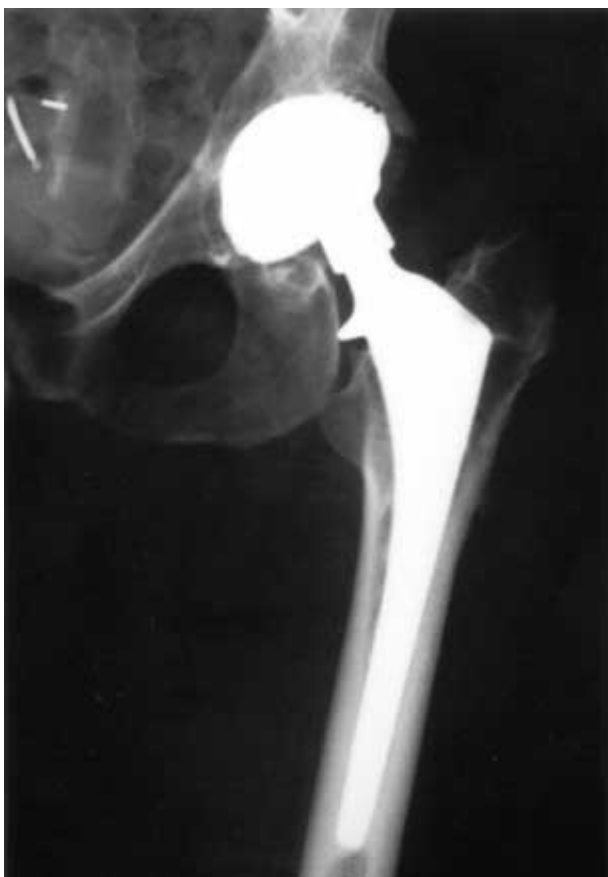
**Fig. 3.** — X-ray of the patient's left hip taken at hospital admission, which shows typical eccentricity of the head within the acetabular component. Small cavitary osteolytic lesions are seen at the anterior inferior acetabular rim and the calcar aspect of the femoral component.

primarily related to the acetabular component and to a lesser extent to the calcar part of the femoral component (1, 3, 5, 9). This has been noted as early as 12 months after implantation, but usually starts after 4 to 6 years. A radiological sign of polyethylene liner wear is the eccentric position of the prosthetic head within the acetabular component on the AP view (9) (fig. 3). Occasionally visible osteolysis is related to direct osseous contact with polyethylene particles. It is related to wear of the acetabular liner and is initiated at the periphery of the prosthetic components. Osteolysis, which is visible as linear or cavitary radiolucencies around the prosthesis is generally pain free (1). In this linear type of osteolysis the outer cortex characteristi-

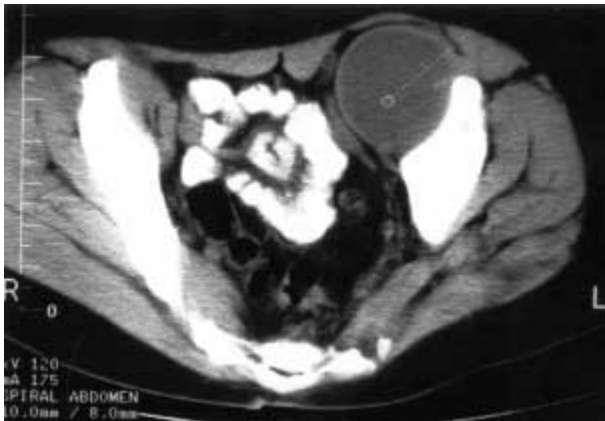
**Fig. 4.** — Pelvic CT-scan of the patient showing the pelvic mass in close relation to the pelvic wall but also to the internal female genitals. Disturbance of the picture caused by the metal components of the implant made it impossible to continue the scan distally and thereby visualize any further relation between the mass and the arthroplasty.

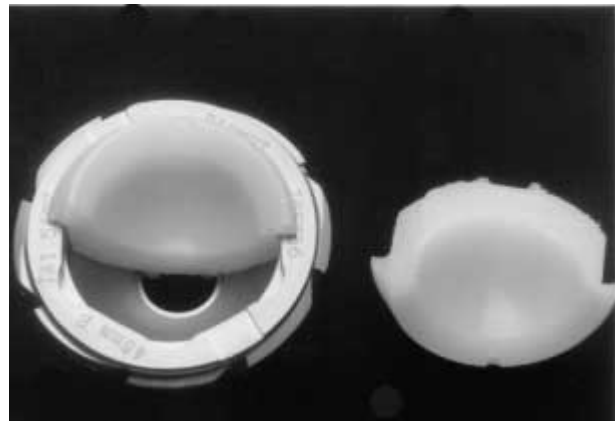
**Fig. 5.** — Photograph showing a similar cup as the one removed at the revision operation. The liner is cut in two pieces, showing the polyethylene thickness at 8 mm in the bottom of the cup. The outer diameter of the cup is 48 mm. Note the hole in the bottom and the threaded outer hemisphere.

The primary prosthetic components were manufactured by Biomet-Merck Inc. The titanium socket was threaded on its outer hemisphere with an outer diameter of 48 mm and a hole in the bottom. Only a small part of the outside hemisphere was porous-coated. The liner was cylindrical in shape inside the cup with the hex-lock mechanism, and the thickness of the polyethylene was 8 mm. The head was 28 mm in diameter and made of chromium-cobalt. The femoral component was a collared Bi-Metric porous-coated stem made of titanium alloy. Both prosthetic components were uncemented. The femoral stem was not loose and was not changed during the revision operation.

The acetabular cup was exchanged with an uncemented hemispheric Trilogy cup (Zimmer) with

a ring-lock mechanism for the polyethylene liner. Osteolytic lesions were grafted with frozen bank bone. The head was also replaced with another of the same diameter, but a longer neck length to stabilize the joint.
