## Stress fracture of the femoral neck as a complication of revision arthroplasty of the knee : A case report

Hakan ATALAR, Mahmut Nedim AYTEKIN, Cuneyd GUNAY, Osman Yuksel YAVUZ

From Fatih University, Ankara, Turkey

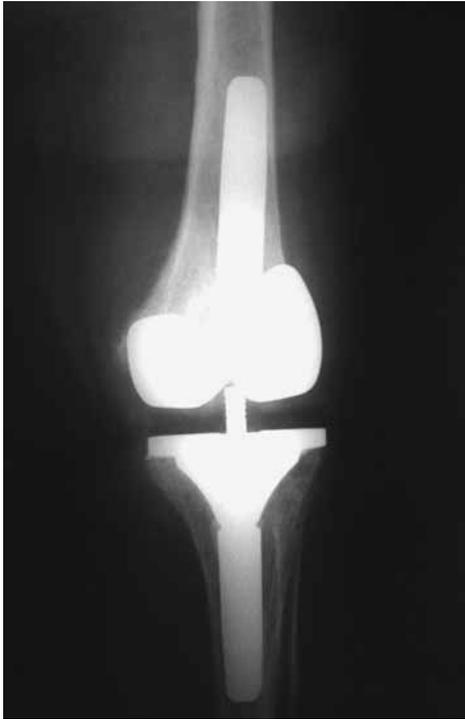
*Fig. 1.* — This anteroposterior radiograph of the right knee shows the total knee revision arthroplasty made prior to the patient's presentation at our clinic.

A 75-year-old woman with arthrosis in the right knee underwent total knee arthroplasty in 2003. In January 2007, she was diagnosed as having an infection at the site of the prosthesis. The prosthesis was removed and the defect was filled with a bone cement spacer. The extremity was immobilised in a plaster cast for the next two months, during which time parenteral antibiotic therapy was given. Revision total knee arthroplasty was then performed (fig 1). In the postoperative period the patient could walk with a cane.

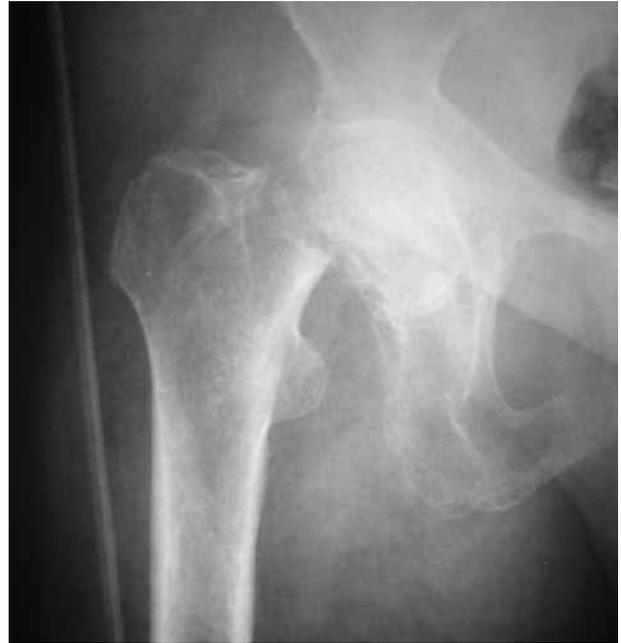
*Fig. 2.* — This anteroposterior radiograph of the right hip shows a displaced fracture of the femoral neck.

Physical examination revealed external rotation of the right leg. Blood cell count and chemical analyses including vitamin D assay were normal. Plain radiographs showed a displaced fracture of the right femoral neck (fig 2). Bone mineral density of the left femoral neck was consistent with osteoporosis (T score,  $-3.5$ ). Bipolar hemiarthroplasty with a Zweymüller Alloclassic straight tapered femoral component (Protasul-100; Zimmer/Centerpulse) was performed (fig 3).

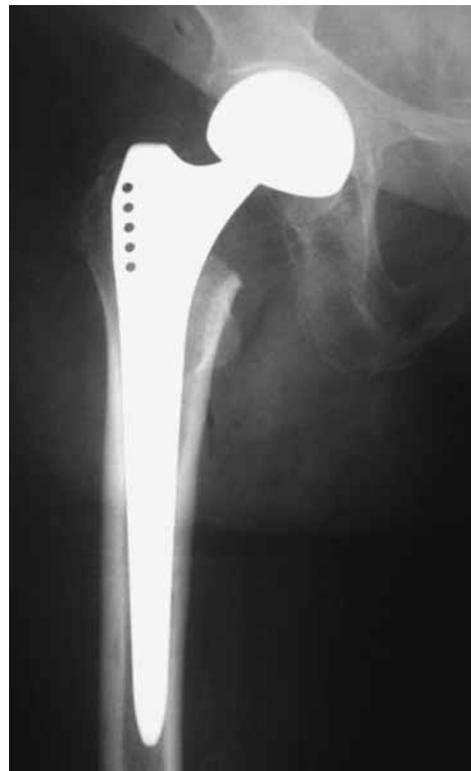
*Fig. 3.* — This postoperative radiograph of the right hip was taken 2 months after hip hemiarthroplasty.
