## A technique to remove a broken guide wire transfixing the hip joint

**A broken guide wire while operating on hip is one of every surgeon's most dreaded nightmares. We report here a method which was used successfully to retrieve a broken guide wire from a patient who was being operated for core decompression and fibular grafting for avascular necrosis of the femoral head.**

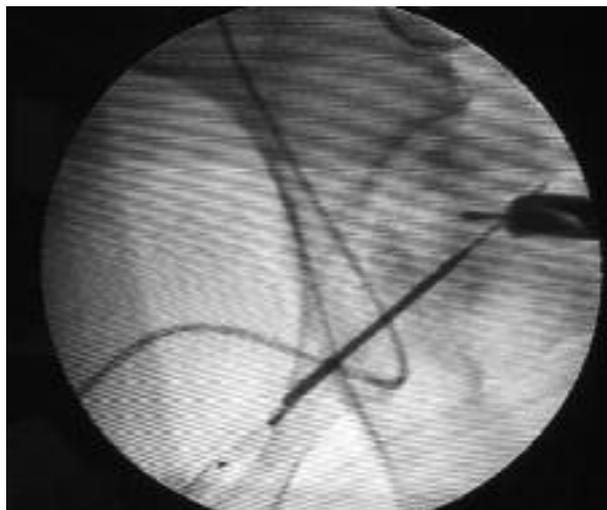
*Fig. 2.* — Broken guide wire being retrieved with the dynamic hip screw tripple reamer.

Various attempts to remove the wire with hand held instruments through the hole drilled in the lateral cortex failed. The broken end of the wire was cleared with the help of a small curette. The dynamic hip screw reamer was once again threaded over the broken guide wire under image intensifier and was advanced till the beginning of the threads of the guide wire which were just beyond the head of the femur, with the help of a hand drill. Once the threads were engaged the broken piece of wire was easily removed by withdrawing the reamer (fig 2 and fig 3).

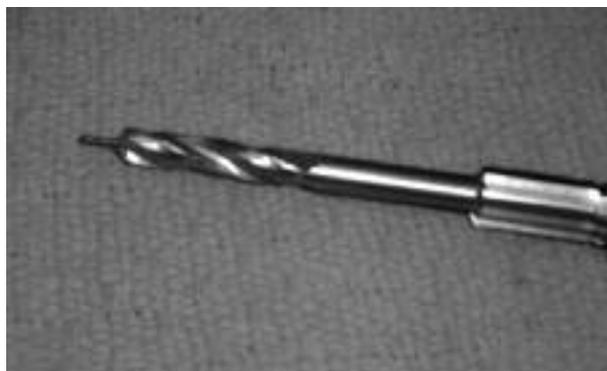
*Fig. 3.* — Broken wire with threads engaged in the dynamic hip screw reamer.

Firstly, whenever one drills the threaded guide wire through the bone of the proximal femur, the effective diameter of its proximal part i.e., the threaded portion of the wire increases by deposition of bone debris in the threads. The same effect can be seen while tapping or drilling the holes when one sees bone debris in the threads of the tap or drill bit, which have to be cleaned frequently. Secondly, the effective diameter of a cannulated device also decreases while reaming or tapping due to bone debris deposition in the lumen of the device. Both these factors combined lead to engagement of the threaded proximal part of the wire in the cannulated device and removal of the wire while withdrawing the device many times. We used this knowledge as a technique to remove the broken wire in our case.
