## Internal fixation of an intertrochanteric femoral fracture after Birmingham hip resurfacing arthroplasty

*From AZ St Blasius, Dendermonde, Belgium*

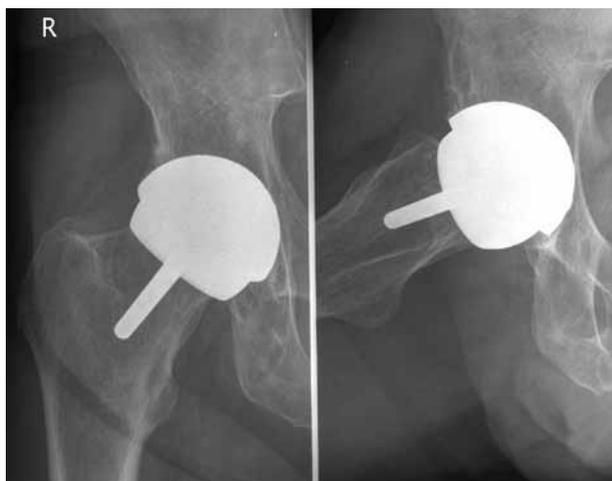
*Fig. 1.* — Birmingham Hip Resurfacing arthroplasty before the injury.

A 72-year-old-man was admitted to the emergency department after a fall with his bicycle. Six years earlier, he had undergone a Birmingham Hip resurfacing arthroplasty of the right hip, through a posterior approach, because of hip arthritis secondary to avascular necrosis (Fig. 1). After the resurfacing he had a pain free hip and returned to a normal level of activity and cycling.

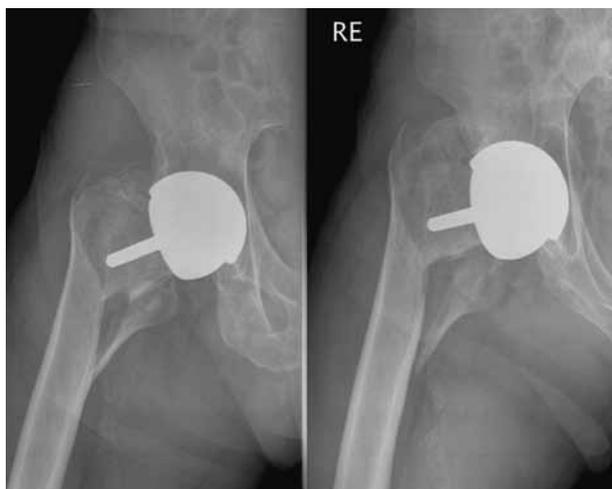
On admission in the emergency department the patient complained of severe pain in the right hip and was unable to stand. Radiographic evaluation showed a complex intertrochanteric fracture of the right femur (Fig. 2). Because of the complexity of the fracture and the presence of a resurfacing implant, placement of an intramedullary nail or dynamic hip screw was not possible. In this relative-

*Fig. 2.* — Intertrochanteric hip fracture with well-fixed femoral resurfacing arthroplasty.

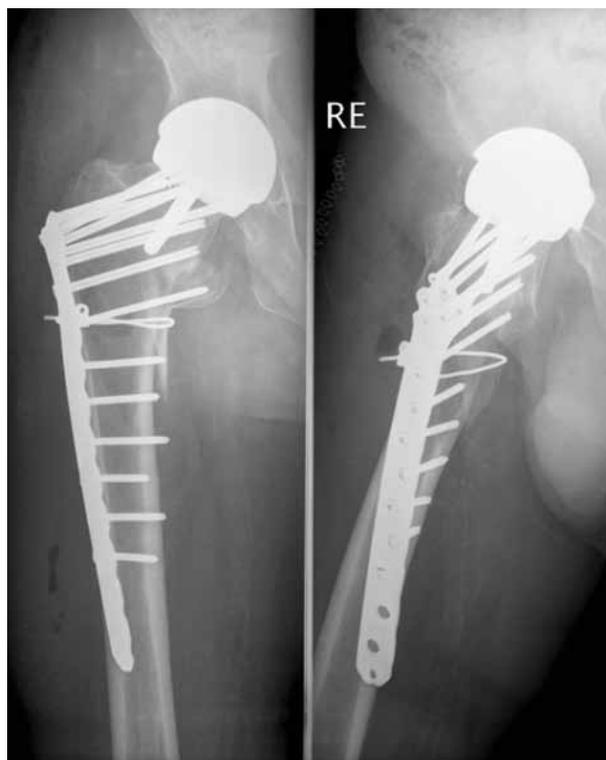
*Fig. 3.* — Postoperative radiograph showing good reduction and fixation with a distal femoral locking plate.

Under general anaesthesia and in supine position on a traction table, the fracture was reduced under fluoroscopy. A lateral incision was made, reduction was completed and the fracture was internally fixed with use of a distal femoral locked plate. The plate was reversed and placed on the proximal femur. This preshaped plate fits nicely on the greater trochanter (Fig. 3). The patient recovered without

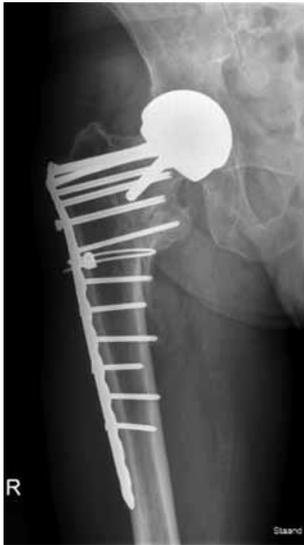
**Fig. 4.** — Radiograph one year postoperatively showing complete healing of the fracture.

complication and was discharged 8 days after surgery, with instructions to walk with crutches and toe-touch weight-bearing for eight weeks. Full weight bearing started after 2 months. The patient had returned to normal level of activity a year after surgery. Radiographs showed good healing of the fracture (Fig. 4). Because of trochanteric pain during sporting activity, the plate was then removed (Fig. 5).

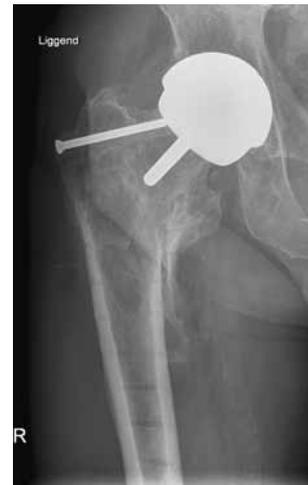
**Fig. 5.** — Well-fixed femoral resurfacing cup after removal of the locking plate.
