Retrograde cement arteriovenogram of nutrient vessels following hemiarthroplasty of the hip

From Tan Tock Seng Hospital, Singapore

Retrograde cement extrusion into the nutrient vessels of the femur is a rare phenomenon in uncomplicated cemented hemiarthroplasty of the hip ; this is a report on three cases.

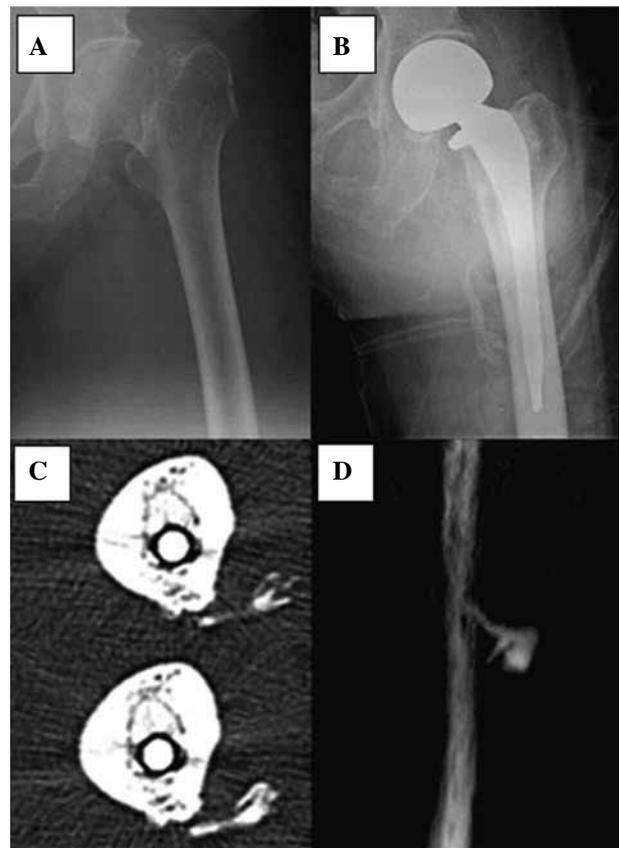
Fig. 1. — The post-operative (B) radiograph in this patient after a right hip hemiarthroplasty showed a radio-opaque density consistent with cement arising from the medial femur shaft not evident in the pre-operative films (A). A computed tomography (CT) scan (C, D) of the right femur showed a continuous linear column of cement extending from the intramedullary canal to the nutrient artery via the posterior cortex of the femur. This density was of uniform calibre initially before extravasation suggesting a cement retrograde arteriogram.

Post-operatively, the patient made an uneventful recovery. The post operative radiographs showed a radio-opaque density consistent with cement arising from the postero-medial aspect of the femur shaft 155 mm distal from the tip of the greater trochanter. A computed tomography (CT) scan of the right femur showed a continuous linear column of cement extending from within the intramedullary canal to the nutrient foramina via the posterior cortex of the femur with no cortical perforation. This density was of uniform calibre initially with no appearance of valvular constriction before cement extravasation (Fig. 1). This suggests an iatrogenic cement retrograde arteriogram.

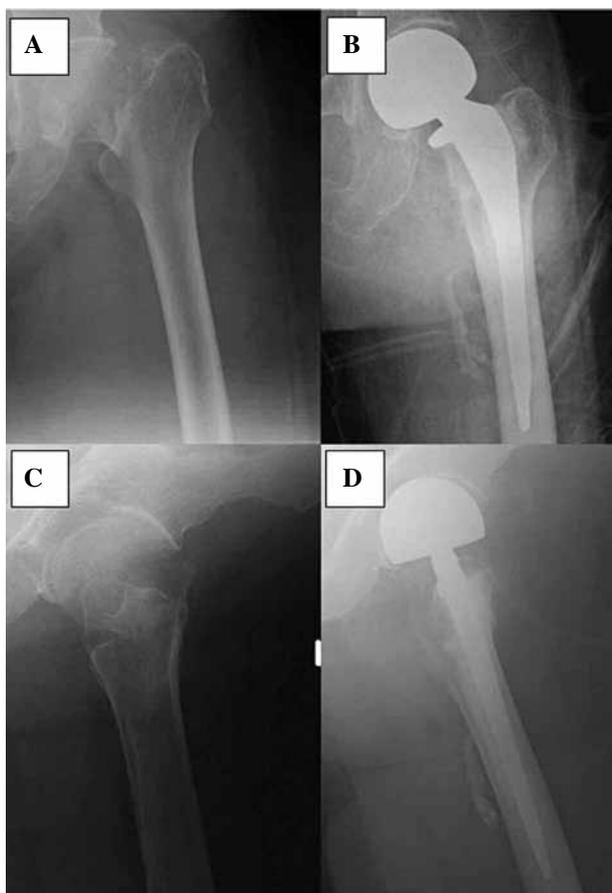
Fig. 2. — A continuous column of dense material extruding from the posterior-medial border of the femur is shown on the radiographs post hemiarthroplasty (B, D) again not evident on pre-operative films (A, C). The presence of valvular like constrictions in the cement extrusion suggests the creation of a retrograde cement venogram.

rior-medial border of the femur. The site of cement extrusion was measured to be 138 mm distal to the greater trochanter. The point of cement communication with the femur was consistent with the normal position of the nutrient foramen and the appearance of valvular constrictions at the start of the density suggested a retrograde cement venogram of the nutrient vein. The calibre of the density then increased significantly, thus suggesting an extravasation of cement into the soft tissues (Fig. 2). The patient recovered well with no post operative complications.

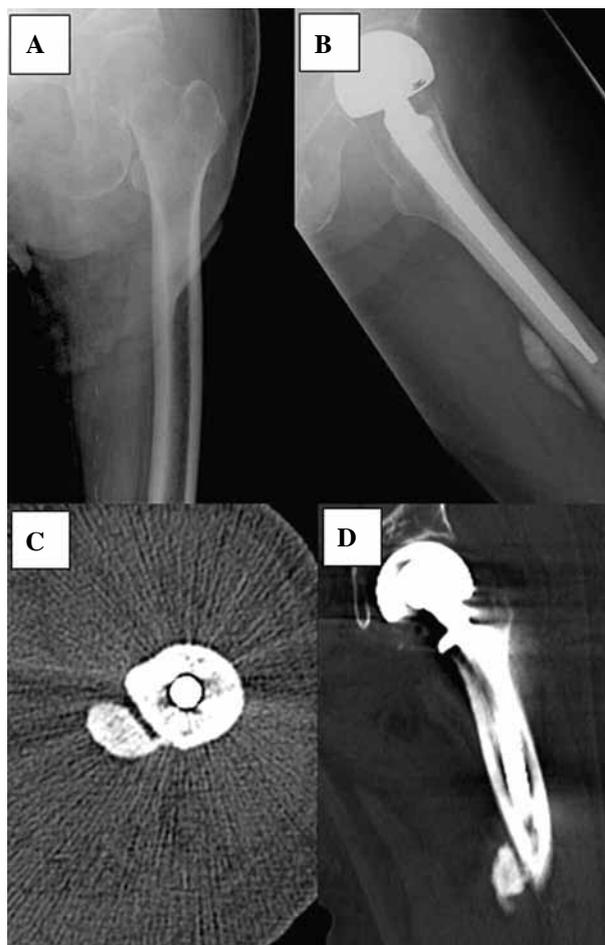
Fig. 3. — A worrisome collection of cement was noted on post-operative radiographs (B) in this patient who underwent hemiarthroplasty of the left hip. Subsequent computed scanning (C, D) revealed an intact femur shaft with the neck of cement extrusion from the nutrient foramina clearly demarcated.

Cement (Stryker Simplex® P Tobramycin) was pressurised at the 3 minute mark with insertion of the prosthesis (Zimmer Versys size 11) at the 5 minute mark. No intraoperative complications were noted. Post operative radiographs revealed a worrisome collection of cement that appeared discontinuous with the femur shaft. A

periprosthetic cortical breach was suspected and the patient was initially placed on non-weight bearing status. A CT scan was subsequently ordered which revealed an intact femur shaft cortex. Cement was seen propagating retrogradely through a nutrient vessel with the neck of this propagation clearly demarcated on the axial and coronal cuts (Fig. 3).
