Unexpected wear of an unicompartmental knee arthroplasty in oxidized zirconium

Anais LUYET, Jean-François FISCHER, Brigitte M. JOLLES, Alexandre LUNEBOURG

From Department of Orthopedic Surgery and Traumatology, EHN, Yverdon Hospital, Yverdon les Bains, Switzerland

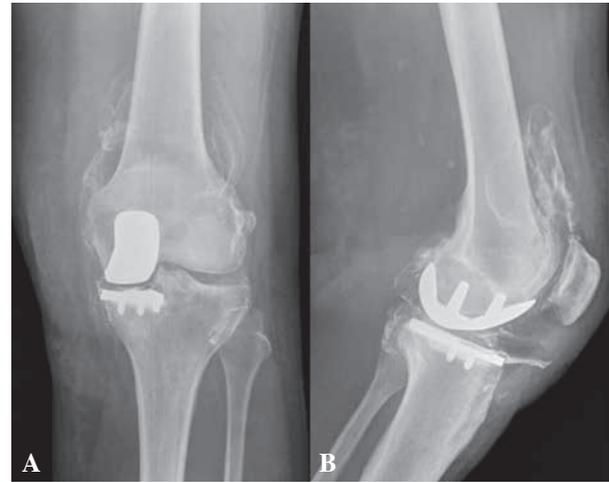
Fig. 1. — At six weeks postoperative, (A) anteroposterior (AP) and (B) lateral radiographs showed a minimal valgus position of the tibial component and capsular opacifications in the suprapatellar pouch. The PE was dislocated anteriorly.

Six weeks postoperatively, clinical outcome was satisfactory. She had no pain and could walk without limitation. The knee presented a light effusion with a range of motion (ROM) of 110-0-0° and the scar was calm. However, standard radiographs showed a minimal valgus position of the tibial component and capsular opacifications in the suprapatellar pouch. The PE was dislocated anteriorly (Fig. 1). A CT scan performed to confirm this diagnosis showed a lot of small intrarticular opacifications (metallic aspect) without any evidence for calcifications (Fig. 2).

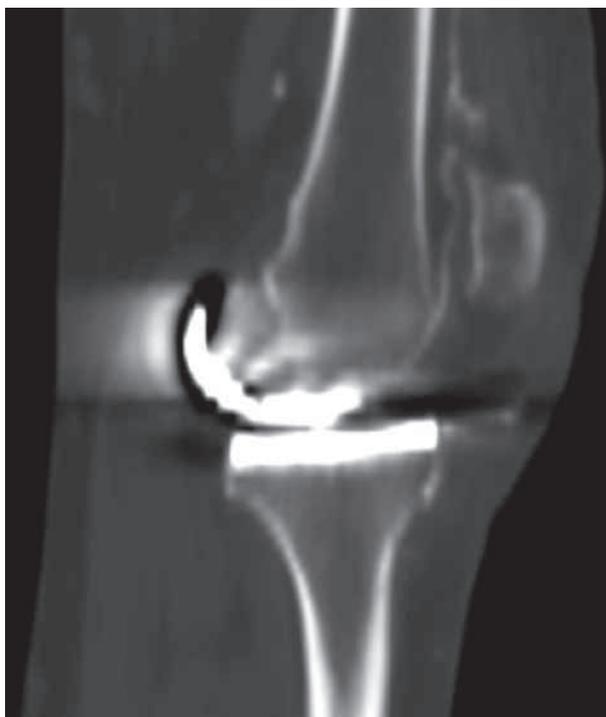
Fig. 2. — A CT scan performed to confirm the dislocation of the polyethylene showed a lot of small intrarticular opacifications (metallic aspect) without any evidence for calcifications.

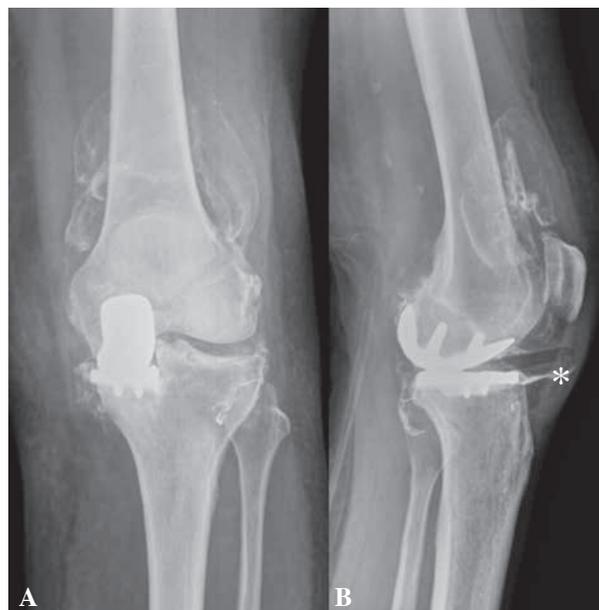
Fig. 3. — The patient was admitted in emergency with a swollen and painful knee. At this point, (A) anteroposterior (AP) and (B) lateral radiographs showed a complete dislocation of the PE (*).

Future revision was decided, but a few days later, the patient was admitted with a swollen and painful knee at the emergency room. The onset was sudden without trigger factor. The knee was swollen, erythematous and the ROM limited to 90°-0-0°. At this point, radiographs showed a complete dislocation of the PE (Fig. 3).

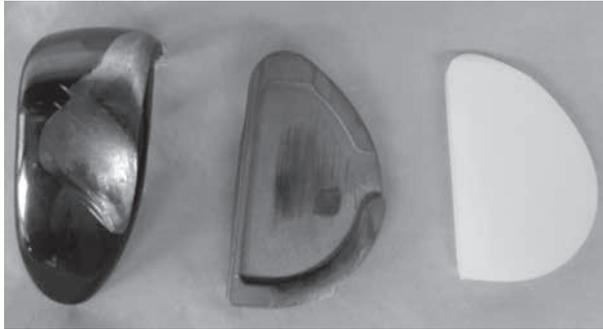
After surgical exposure, the PE was found under the patellar tendon. The whole intra-articular soft tissues and particularly the synovial tissue presented an aspect of black sludge due to excessive metallosis. This was explained by premature wear of the posterior part of the femoral implant which was in contact with the tibial metal-backed implant due to PE dislocation (Fig. 4). Then, the femoral component was removed carefully using a bone scissor with interchangeable blade and the tibial compo-

Fig. 4. — Components explanted which presented a major defect of the posterior part of the femoral implant, a minor defect of the tibial component and an intact PE.

nent was removed by a recut of 2 mm. A large synovectomy was performed but a complete removal of wear metallic particles was not possible. As bone surfaces and cartilage in the two other compartments were intact after the removal of the two components, a revision by a new UKA was done using an all-PE cemented tibial. Both femoral and tibial implants were replaced by a new cemented femoral implant in OZ (same size as the primary UKA) and a 11 mm all-PE highly cross-linked cemented tibial implant (same size as the primary UKA) (Journey Uni, Smith&Nephew, Inc. Memphis). Microbiological samples were sterile and histological examination confirmed metallosis with histiocytic reaction to foreign body. There were no postoperative complications. Two months after the revision she was satisfied and the same surgery was performed on the other knee. On the basis of clinical and radiographic assessments at the 2 year follow-up, no evidence of implant loosening or wear were noted (Fig. 5). The knee was indolent without intra-articular effusion. She was able to walk without limitation and the ROM was 110-0-0 with a Knee Society Knee score of 87 points and the Knee Society Function score of 90 points.

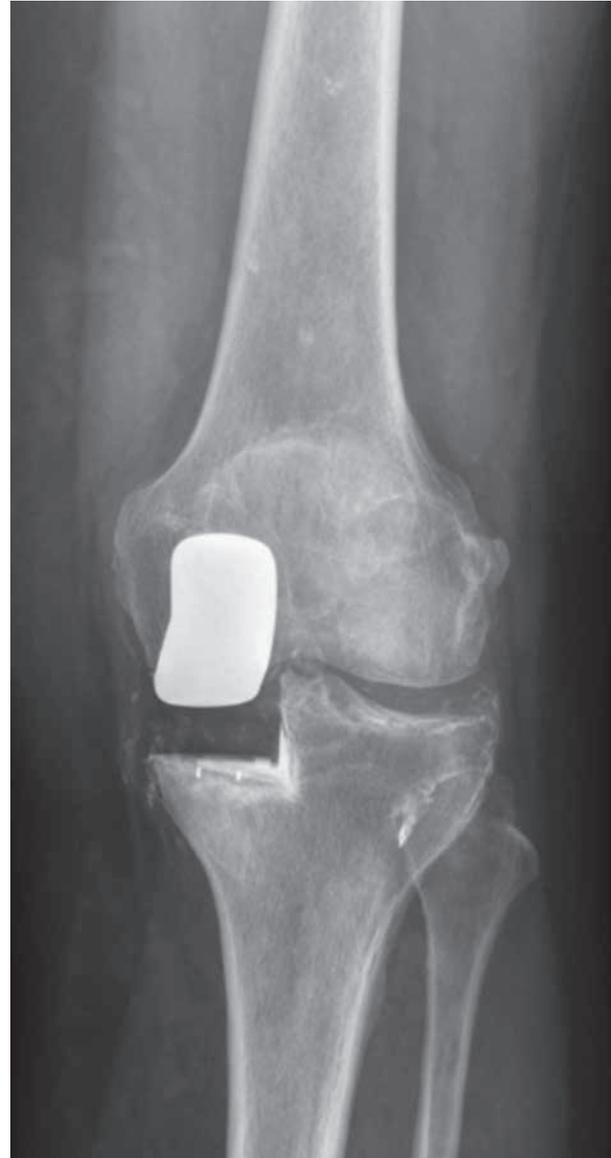
Fig. 5. — The revision UKA AP radiographs at 2 year post-operatively reveal that the components are well-fixed and well-aligned.

quires revision, the best outcome is achieved when it is converted into a TKA (8). However in our situation, we decided to replace the UKA by another UKA, because it was an early failure and the lateral and the patella-femoral compartment were intact. Indeed, Lecuire et al. advocated that it is possible and reasonable to perform partial or total replacement of UKA by another UKA without using a TKA especially if there is no deterioration of the

two others compartments and if the cruciate ligaments are intact (17). The use of an all-PE cemented tibial component was decided to prevent the patient from experimenting another dislocation of the PE. Moreover, using an all-PE prevent the risk of the femoral component in OZ to be in contact with titanium alloy tibial tray as was previously described with TKA (4). Finally, the recent literature shows that all-PE tibial implant have the same survivorship and clinical outcome as metal backed components (21,30). However, patient and surgeon have to be aware that using all-PE tibial component could lead to a tibial component collapse and thus induce a harder revision surgery of UKA (1). At the one year follow-up the outcome was good, but longer follow-up is required to demonstrate that our treatment option was correct in this situation.
