A case of an atraumatic implant failure after primary rotating-hinge total knee arthroplasty

We present a rare case of 70-year-old Caucasian, male patient who suffered an atraumatic femoral stem breakage in a primary NexGen® Rotating Hinge Knee (Zimmer-Biomet®, Warsaw, IN, USA).

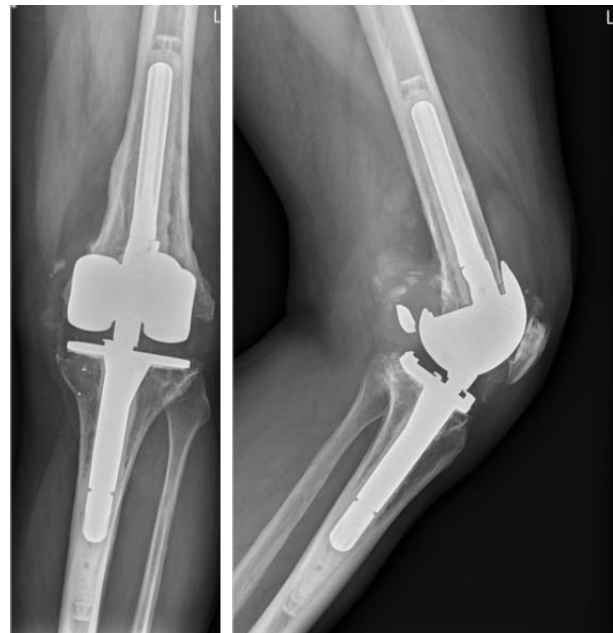
Seven years after the primary rotating hinge knee [RHK] arthroplasty, another X-ray was obtained because of worsening of the patient's complaints. He experienced more pain and had trouble walking. This X-ray image revealed a fracture of the RHK

Figure 1. — Anteroposterior and lateral X-ray of the left knee showing implant breakage.

implant on the transition of the femoral stem and the femoral component of the hinge. Broken parts of the implant were visible outside of the joint (Fig 1). A technecium-99m bone scintigraphy and a low dose SPECT-CT were performed for the second time. Healing of the fracture of the left medial cortical femur was visualized. Loosening of the femoral component of the implant was observed. The active spot anterior against the implant in the medial condyle of the femur was still lighting up. Because of these findings, a revision RHK prosthesis was implanted under spinal anesthesia two days later. Follow-up one month after the operation, the patient was very satisfied and a good range of motion of the knee was noted.

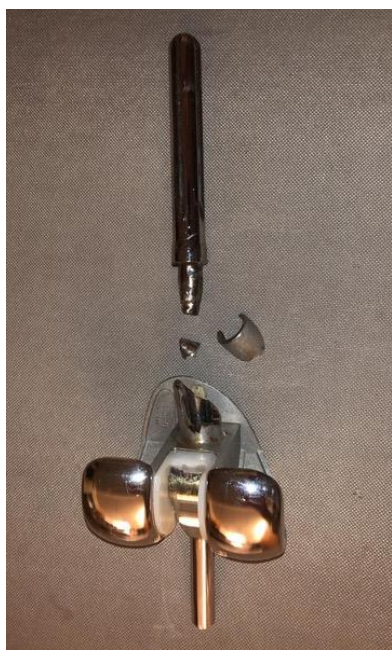
Figure 2. — Image of the broken implant viewed from posterior.

due to loosening of a component and the high axial loads. In the current case report, we described an atraumatic RHK implant failure at the transition of the femoral stem and the femoral component of the hinge prosthesis (Fig 2). In our opinion a plausible explanation for the failure of this specific case could be that the femoral component of the implant loosened after five years. Therefore, loading stresses on the femoral component changed and the implant broke on a weak point being the transition of the femoral stem and the femoral component of the hinge.
