## Pseudotumor After Ceramic-on-Ceramic Total Hip Arthroplasty: A Case Report

**ABSTRACT** Pseudotumors, typically associated with metal-on-metal (MoM) bearings in total hip arthroplasty (THA), have rarely been reported in ceramic-on-ceramic (CoC) THA. This case details the development of a pseudotumor in a 70-year-old female six years after an uneventful CoC THA for osteoarthritis. The patient presented with groin pain and swelling, and imaging revealed a fluid-filled mass at the hip. Aspiration provided temporary relief, but the cyst recurred. Surgical intervention showed no macroscopic wear on the bearing surfaces, but 40cc of fluid was evacuated from the acetabulum after cup removal, confirming an articular origin. Pathology revealed a macrophage-driven pseudotumor without foreign material, suggesting an inflammatory or hypersensitivity response to the ceramic materials. This case underscores the rare but significant occurrence of pseudotumors in CoC THA, emphasizing the need for thorough clinical evaluation, early detection, and intervention, as well as further research to understand the underlying mechanisms.

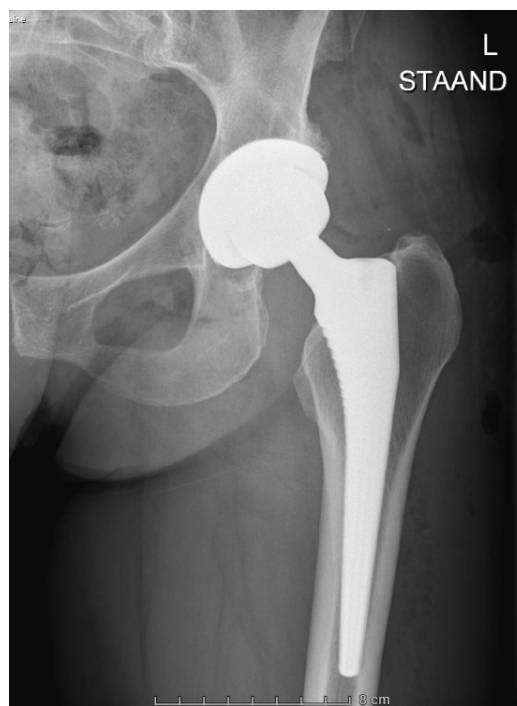
Fig. 1 — Post-operative x-ray of the THA.

in her left hip. A ceramic-on-ceramic total hip arthroplasty (THA) was selected, taking into account the patient's age and activity level. The procedure was performed via a posterior approach using a cementless titanium alloy stem (Avenir, Zimmer Biomet, Warsaw, IN, USA) combined with a ceramic femoral head (BIOLOX Option, 40 mm, -3 mm, CeramTec, Plochingen, Germany) mounted on a titanium alloy sleeve. The acetabular component consisted of a monobloc titanium shell with an integrated ceramic liner (Maxera, 52 mm, Zimmer Biomet, Warsaw, IN, USA) (Figure 1).

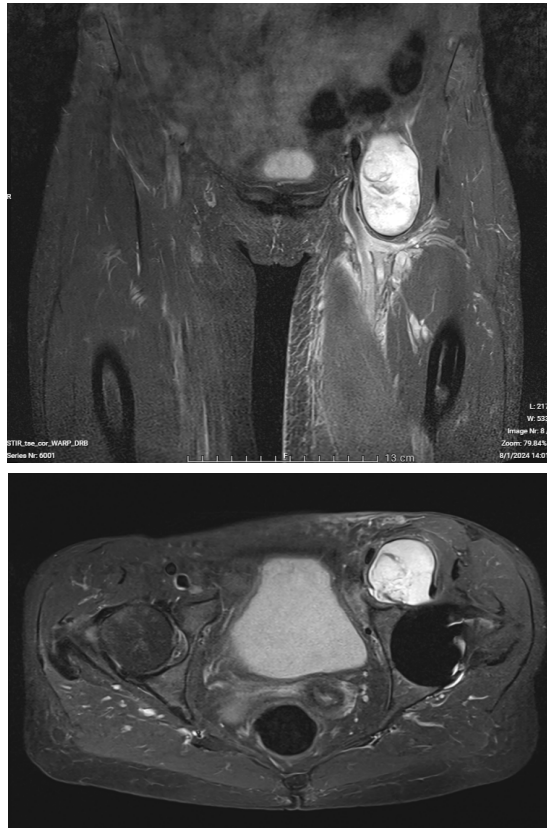
Fig. 2 — Coronal (a) and axial (b) MRI images of the fluid-filled mass, compressing the femoral artery and vein.

At 6 years postoperatively, the patient returned to the clinic with complaints of persistent groin pain upon walking. She also reported a warm swelling at the groin region. On physical examination, a non-tender mass was noted in the anterior hip region, and the patient exhibited mild discomfort with palpation. CT scan and MRI revealed a large (74 x 43 x 49 mm) fluid-filled mass at the anteromedial aspect of the hip,

suspected to be an iliopsoas bursitis by the radiologist, with compression of the femoral vein (Figure 2). Both components were positioned within acceptable limits, with a CT-measured cup inclination of 40° and anteversion of 35° with adequate anterior coverage of the cup (Figure 3).

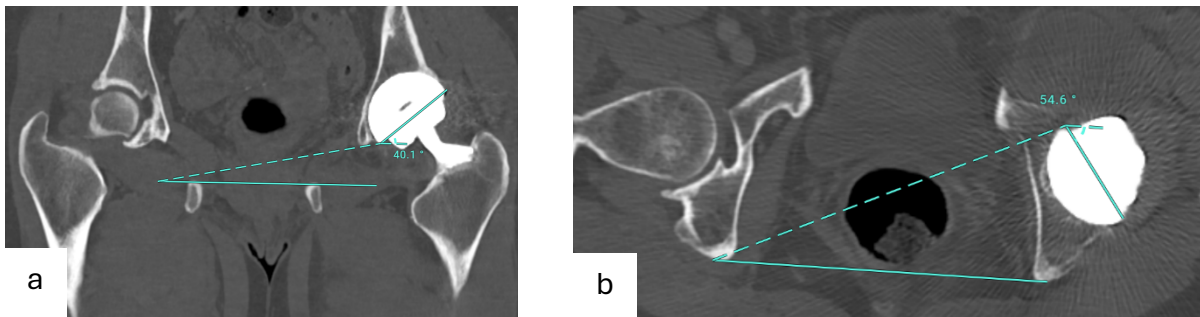
Fig. 3 — Coronal (a) and axial (b) CT images of the respectively the cup inclination of  $40^\circ$  and anteversion of  $35^\circ$  ( $90^\circ - 54.6^\circ = 35.4^\circ$ ). Adequate anterior bony coverage of the cup is noted on the axial image (b).

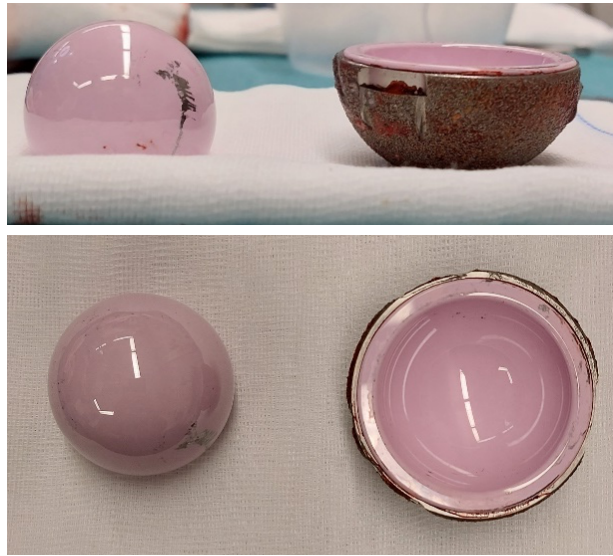
During the procedure, minimal intra-articular fluid was found, and the THA was dislocated for inspection. No signs of infection were noted. The bearing surfaces were found to be free of any macroscopic wear, and the ceramic femoral head was removed (showing

typical pencil marks due to contact with the metal cup after removal) (Figure 4). Neither the titanium sleeve of the biolox option head, nor the trunnion of the stem showed any signs of trunnionosis. The acetabular cup was easily removed without bone loss, and spontaneous evacuation of 40cc of dark-reddish viscous fluid into the acetabulum confirmed that the cyst had an intra-articular origin, arising just anterior to the anterior acetabular wall. The cyst wall was carefully mobilized and resected, and the femoral artery was well-palpated during this dissection.

*Fig. 4 — Cup and head after removal, showing no macroscopic signs of wear.*

A 52mm cementless press fit acetabular cup (Allofit, Zimmer Biomet, Warsaw, IN, USA) with a 36mm cross-linked polyethylene liner was inserted after progressive reaming. A new ceramic head (BIOLOX Option, 36 mm, +0 mm, CeramTec, Plochingen, Germany) was placed on the femoral component after stability testing. Both the cyst wall and the intra-articular fluid were submitted for microbiological and histopathological evaluation. Based on the culture result obtained after aspiration, the patient was started on a 5-day course of intravenous Vancomycin pending final culture results. After the cultures came back negative, she was discharged to a rehabilitation clinic on postoperative day 7. The patient's rehabilitation course was unremarkable, and at a 2-year follow-up, she reported complete resolution of her symptoms.
