## Head-neck disassembly of an uncemented revision stem treated by addition of a proximal spacer

**A 67-year-old woman underwent revision total hip replacement with a long, distally fixed uncemented stem inserted through a transfemoral approach. Initial stability was not achieved and the stem subsided early. Probably due to a conflict with the minor trochanter, the prosthetic head detached from its neck. Instead of a re-revision of the stem, a proximal spacer was inserted to restore stability and to compensate for leg-length discrepancy. This has proved to be a stable and satisfactory solution after three years follow-up.**

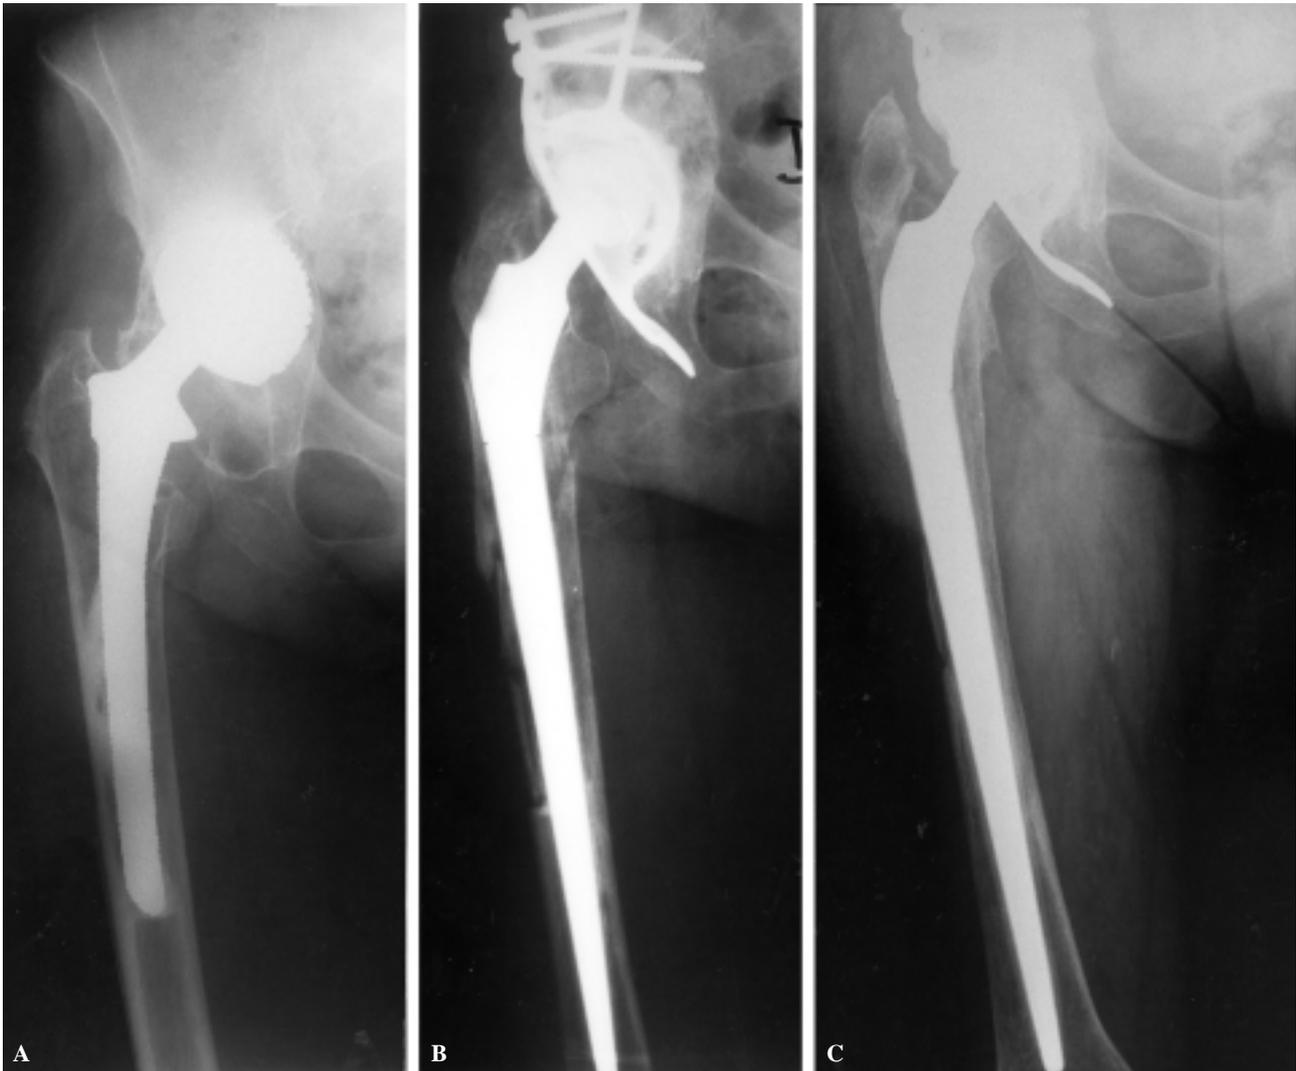
**Fig. 1.** — A) Preoperative radiograph : there is slight protrusion of the threaded cup. The uncemented stem appears to be extensively fixed to the femoral canal. B) The postoperative radiograph shows the acetabular reconstruction using a bone allograft and an anti-protrusion cage. A transfemoral approach was necessary to remove the previous stem : a modular Profemur prosthesis was implanted in order to provide distal fixation. C) The progressive subsidence of the femoral component led to a 30-mm shortening of the right limb after six months.

previously for osteoarthritis. Over the last two years the patient had developed increasing pain localised at the buttock and the thigh. Preoperative radiographs showed progressive central migration of the socket and slight protrusion. No signs of loosening of the femoral stem were evident (fig 1a). Revision surgery was performed in April 1999. Through a lateral approach in supine position the loosened cup was easily removed. A transfemoral approach according to Wagner (11) was needed to remove the long and extensively porous-coated stem that was well fixed to the femoral canal. Some fragmentation of the cortical bone could not be avoided. A homologous bone graft was used for the massive acetabular defect and the reconstruction was completed with a Burch-Schneider Anti-Protrusio Cage (Sulzer, Switzerland) and a Müller polyethylene cemented cup. The femoral revision was performed using a Profemur modular stem (Cremascoli Ortho S.p.A., Italy). The Profemur stem is a cementless titanium alloy prosthesis consisting of three parts: diaphysis,

metaphysis and ball head. It has a rough surface with longitudinal antirotation wings. In the present case the longest (215 mm) diaphyseal component was used in order to provide a stable distal fixation. The stem was assembled using an extra-small proximal part and a 28-mm ceramic head for a total length of the implant of 295mm. The femoral osteotomy site was closed and fixed with a Dexon loop (fig 1b). Postoperatively a brace was applied and

weight bearing was not permitted. Despite these precautions, the first radiograph, performed thirty days after surgery, revealed a 10-mm subsidence of the femoral stem. Weight bearing was delayed for an additional three months, but a progressive subsidence was observed up to six months after surgery, when the stem probably achieved its definitive stability : the final shortening measured some 30 mm (fig 1c). Nevertheless, the patient had been able to

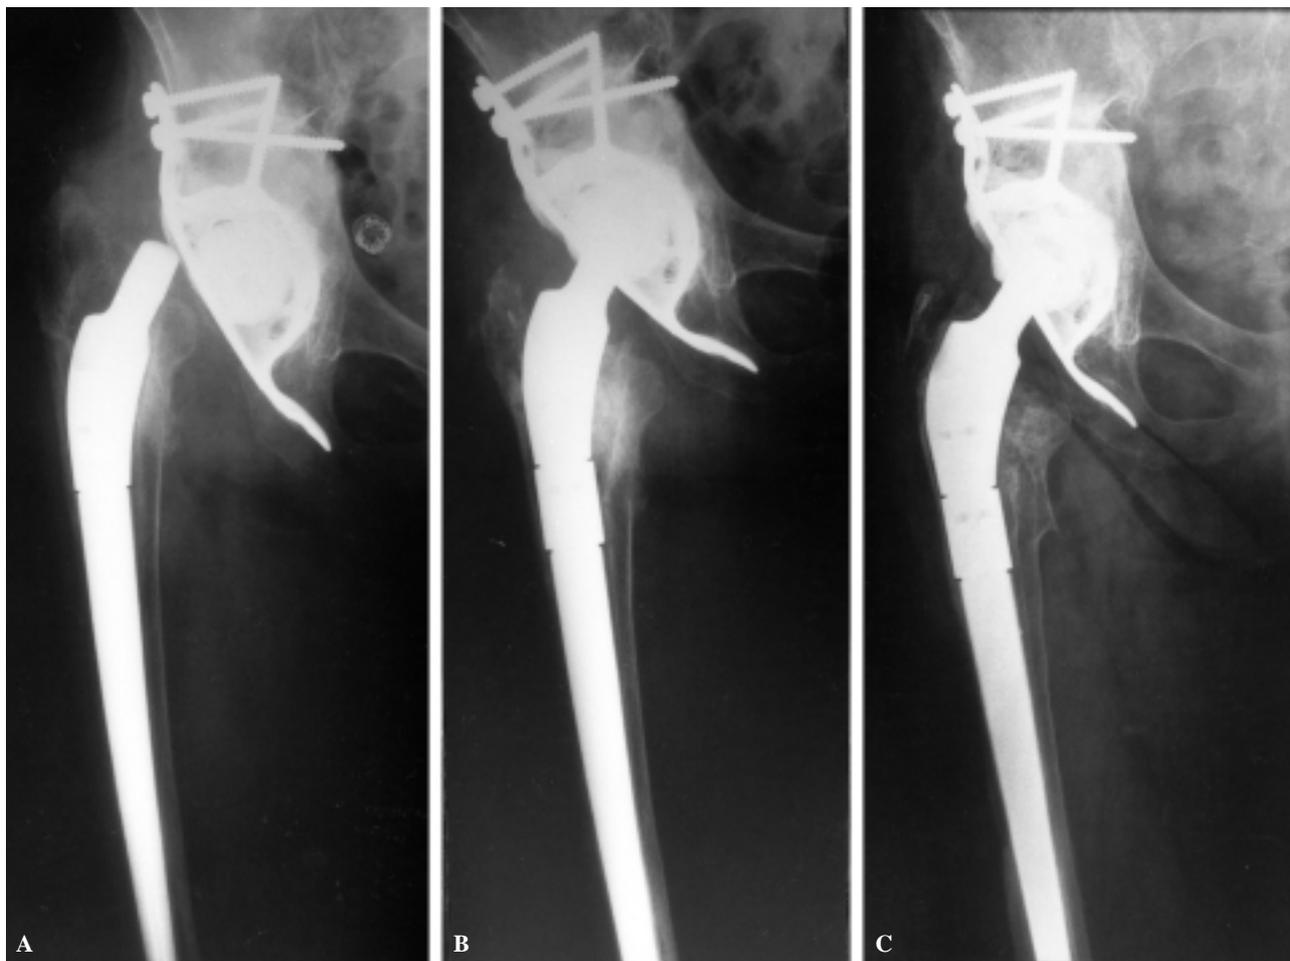
**Fig. 2.** — A) The subsidence of the femoral stem was complicated with head-neck disassembly probably because of impingement with the calcar. B) Insertion of a spacer between the components of the modular stem allowed reducing the prosthesis dislocation and partially restoring the leg shortening. C) The 3-year radiograph demonstrated no additional subsidence of the femoral component.

recover an effective range of motion and a satisfactory deambulation, and the functional recovery appeared to be fairly good at follow-up in January 2000. One week later, while performing a simple movement of flexion and slight adduction, the patient experienced a sudden click followed by complete functional disability and impossibility to bear weight. Standard radiographs showed dislocation of the femoral stem and neck while the head of the prosthesis remained inside the polyethylene cup : no additional subsidence could be observed (fig 2a).

The reason for disassembly was found to be impingement of the base of the ball head against the lesser trochanter, acting as a levering system.

The modularity of the femoral revision stem allowed restoration of the joint stability and some compensation for subsidence by interposition of a 26-mm long spacer between the proximal and distal femoral components (fig 2b). This was performed after the proximal component had been removed and the stability had been tested and confirmed.

The postoperative recovery was uneventful and a quick functional recovery was achieved. Three years later the postoperative 5-mm shortening was unchanged and no further subsidence of the stem was measured (fig 2c).
